**Flood Control Project Maintenance
Levee Inspections****LMA District Cover Sheet****Spring 2015 Levee Inspection Results****Reclamation District No. 0524 Middle Roberts Island**

Spring 2015 Levee Inspection Results

Reclamation District No. 0524 Middle Roberts Island

Waterway			Bank	Unit Miles
Unit No. 01 San Joaquin River			Left	6.20
	Spring (March - May)	Summer (June - August)	(September - November) Fall	Winter (December - February)
Unit Maintenance Rating (Fall Only)				
Date of Inspection	04/21/2015 - 04/21/2015			
DWR Inspector	Richard Willoughby			
Accompanied By	Mario Jaques RD 524

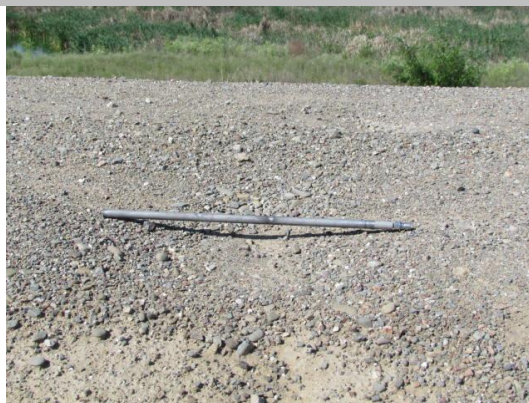
Photo 1 of 3 : SP_2015_RD0524_107_3_20150309_00006.jpg

LM Start	0.21	Rating **	M	Issue No.	3
LM End	0.21	Issue Type +	Ma	Location *	CR
Category	Earthen Levee			GPS Latitude/Longitude	
				Start	End
Item	Crown Surface / Depressions / Rutting			37.938890 °	37.938890 °
				-121.343657 °	-121.343657 °
DWR ID	DWR_RD0524_01_s_2012_3				
Action/Comments					
Repair depressions or ruts in the crown or slope. Inspector Comments: No change in status.

Looking west at 3" depression on levee crown. (Spring 2012)

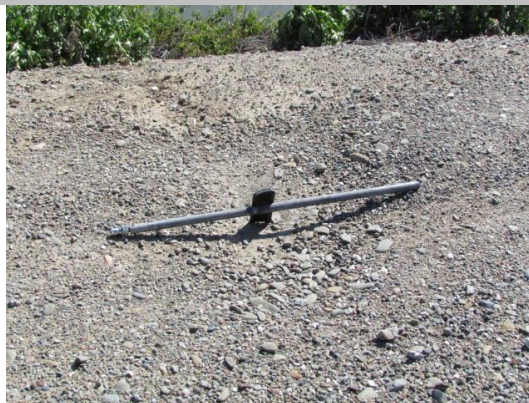
Photo 3 of 3 : SP_2015_RD0524_107_3_20150309_00008.jpg

LM Start	0.21	Rating **	M	Issue No.	3 (cont)
LM End	0.21	Issue Type +	Ma	Location *	CR
Category	Earthen Levee			GPS Latitude/Longitude	
				Start	End
Item	Crown Surface / Depressions / Rutting			37.938890 °	37.938890 °
				-121.343657 °	-121.343657 °
DWR ID	DWR_RD0524_01_s_2012_3				
Action/Comments					
Repair depressions or ruts in the crown or slope.					
Inspector Comments: No change in status.

Looking east at 3" depression on levee crown. (Spring 2012)

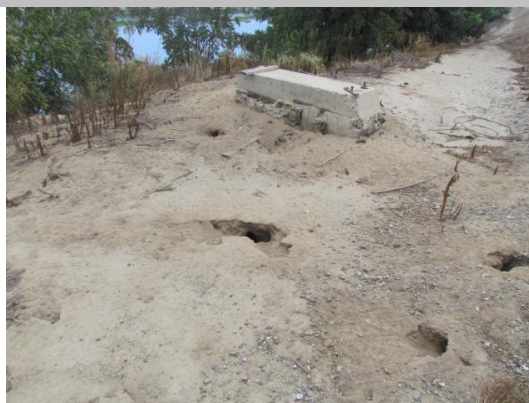
Photo 2 of 2 : SP_2015_RD0524_107_174_20150309_00144.jpg

Looking southeast at several rodent holes on waterward slope.

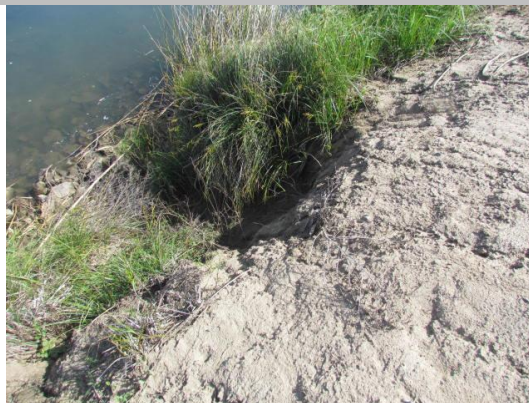
Photo 1 of 2 : SP_2015_RD0524_107_180_20150309_00147.jpg

LM Start	0.34	Rating **	M	Issue No.	180
LM End	0.34	Issue Type +	Ma	Location *	WS
Category	Earthen Levee			GPS Latitude/Longitude	
				Start	End
Item	Erosion / Bank Caving			37.938461 °	37.938461 °
				-121.341626 °	-121.341626 °
DWR ID	DWR_RD0524_01_s_2014_180				
Action/Comments					
Schedule repair of erosion site prior to the next inspection. Inspector Comments: Erosion is located along the lower level of waterward slope.

Looking southeast at erosion on waterward toe.

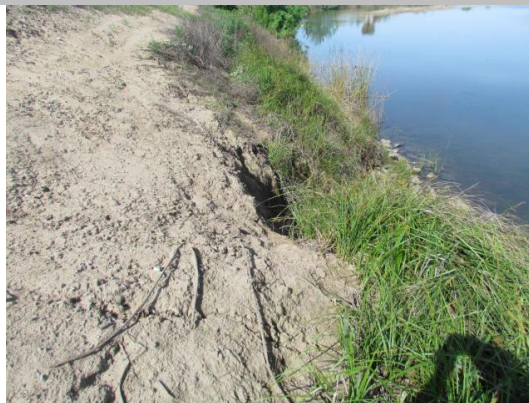
Photo 2 of 2 : SP_2015_RD0524_107_180_20150309_00148.jpg

LM Start	0.34	Rating **	M	Issue No.	180 (cont)	
LM End	0.34	Issue Type +	Ma	Location *	WS	
Category	Earthen Levee			GPS Latitude/Longitude		
				Start		End
Item	Erosion / Bank Caving			37.938461 °	37.938461 °	
				-121.341626 °	-121.341626 °	
DWR ID	DWR_RD0524_01_s_2014_180					
Action/Comments						
Schedule repair of erosion site prior to the next inspection. Inspector Comments: Erosion is located along the lower level of waterward slope.

Looking northeast at erosion on waterward toe.

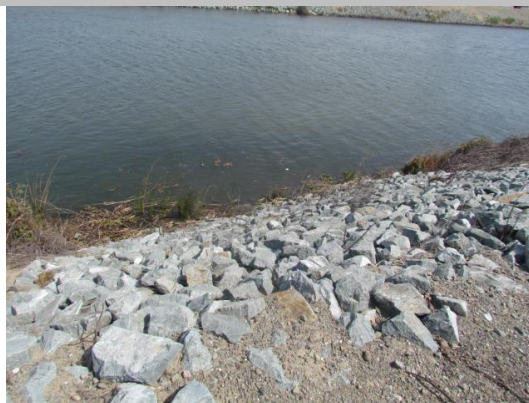
Photo 1 of 2 : SP_2015_RD0524_107_131_20150424_00206.jpg

LM Start	0.40	Rating **	U	Issue No.	131
LM End	0.40	Issue Type +	Ma	Location *	WS
Category	Supplemental			GPS Latitude/Longitude	
				Start	End
Item	DWR Erosion Survey			37.938870 °	37.938870 °
				-121.340460 °	-121.340460 °
DWR ID	DWR_RD0524_01_s_2015_131				
Action/Comments					
Inspector Comments: 6/19/2014: No significant change observed. 08/13/2013: No significant change at this site. 8/7/2012: The erosion is at the upper levee slope, and likely caused by slope slip. The lower levee slope is covered with dense vegetation. [2014 Site ID:RD0524U01RM40.99] 4/21/2015 Site repaired.

Looking east at repaired site.

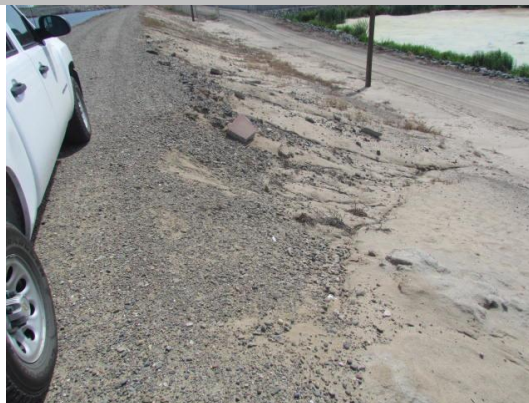
Photo 1 of 2 : SP_2015_RD0524_107_170_20150424_00207.jpg

LM Start	0.41	Rating **	M	Issue No.	170
LM End	0.65	Issue Type +	Ma	Location *	WS
Category	Earthen Levee			GPS Latitude/Longitude	
				Start	End
Item	Slope Stability			37.938628 °	37.938015 °
				-121.340385 °	-121.336165 °
DWR ID	DWR_RD0524_01_s_2015_170				
Action/Comments					
Repair slope instability. Inspector Comments: Several slope instabilities within this reach.

Looking south at slope damage on waterward shoulder.

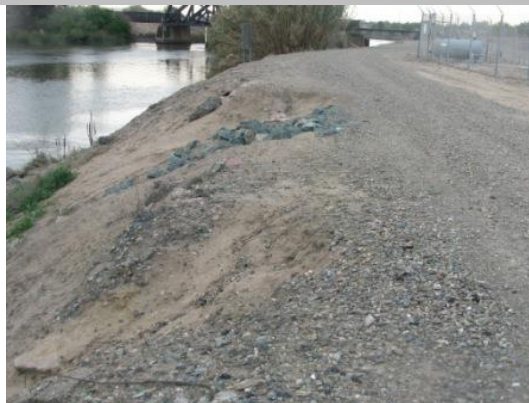
Photo 1 of 3 : SP_2015_RD0524_107_13_20150309_00017.jpg

LM Start	0.64	Rating **	M	Issue No.	13
LM End	0.65	Issue Type +	Ma	Location *	WS
Category	Earthen Levee			GPS Latitude/Longitude	
				Start	End
Item	Slope Stability			37.938105 °	37.938023 °
				-121.336288 °	-121.336173 °
DWR ID	DWR_RD0524_01_s_2012_13				
Action/Comments					
Repair slope instability.					
Inspector Comments: Erosion extends from mid levee slope to shoulder.

View of the erosion.

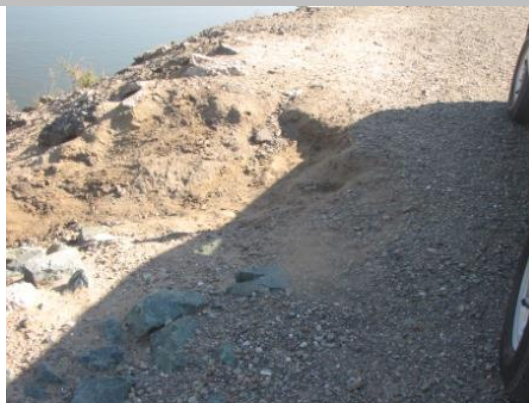
Photo 3 of 3 : SP_2015_RD0524_107_13_20150309_00019.jpg

Update view of the erosion site.

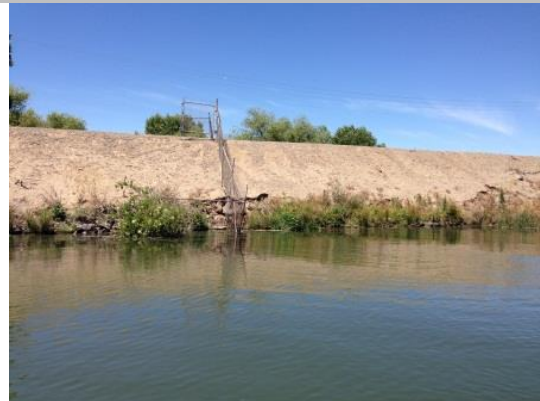
Photo 1 of 1 : SP_2015_RD0524_107_132_20150309_00131.jpg

LM Start	0.76	Rating **	U	Issue No.	132
LM End	0.76	Issue Type +	Ma	Location *	WS
Category	Supplemental			GPS Latitude/Longitude	
				Start	End
Item	DWR Erosion Survey			37.936821 °	37.936821 °
				-121.334582 °	-121.334582 °
DWR ID	DWR_RD0524_01_s_2015_132				
Action/Comments					
Inspector Comments: 06/19/2014: No significant change observed. 08/13/2013: No significant change at this site. 08/07/2012: The site has been visited by boat survey. No significant change observed. 08/23/2011: The site is located immediately upstream of a Railroad bridge. Dense vegetation at the water line blocks the view of erosion. [2014 Site ID:RD0524U01RM41.39]

Front view of the erosion site. Vegetation is visible.

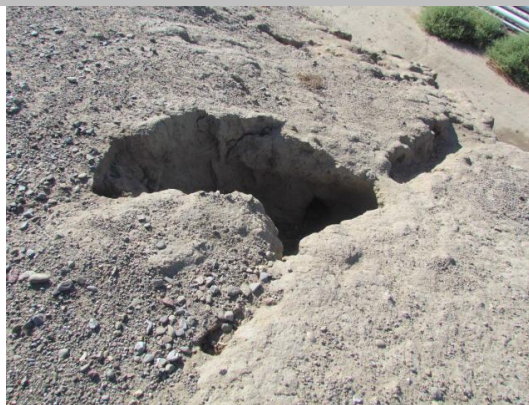
Photo 1 of 5 : SP_2015_RD0524_107_2_20150309_00001.jpg

Looking southwest at hole on landward shoulder.

Action/Comments					
Schedule repair of erosion site prior to the next inspection. Inspector Comments: Several holes and finger erosions on landward slope.

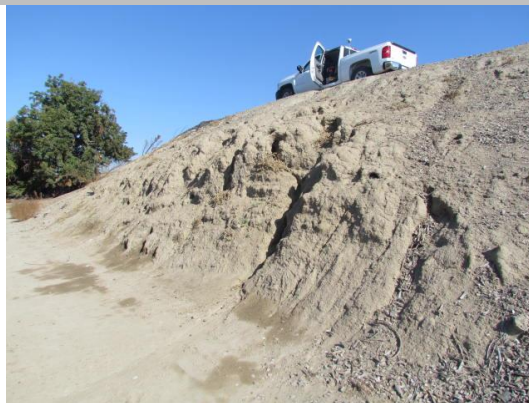
Photo 5 of 5 : SP_2015_RD0524_107_2_20150309_00005.jpg

LM Start	0.81	Rating **	U	Issue No.	2 (cont)	
LM End	0.81	Issue Type +	Ma	Location *	LS	
Category	Earthen Levee			GPS Latitude/Longitude		
				Start	End	
Item	Erosion / Bank Caving			37.936093 °	37.936004 °	
				-121.334648 °	-121.334615 °	
DWR ID	DWR_RD0524_01_f_2013_2					
Action/Comments						
Schedule repair of erosion site prior to the next inspection.						
Inspector Comments: Several holes and finger erosions on landward slope.

Looking northeast at several finger erosion on landward slope.

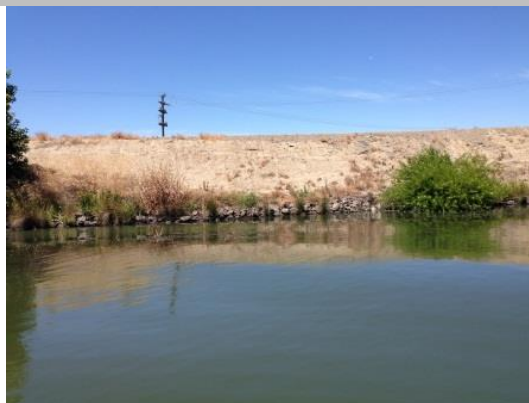
Photo 1 of 1 : SP_2015_RD0524_107_133_20150309_00132.jpg

LM Start	0.83	Rating **	U	Issue No.	133
LM End	0.83	Issue Type +	Ma	Location *	WS
Category	Supplemental			GPS Latitude/Longitude	
				Start	End
Item	DWR Erosion Survey			37.935930 °	37.935930 °
				-121.334133 °	-121.334133 °
DWR ID	DWR_RD0524_01_s_2015_133				
Action/Comments					
Inspector Comments: 06/19/2014: No significant change observed. 08/13/2013: Site was discovered during boat survey. The dense vegetation blocks a clear view of the erosion. Size of erosion site was very roughly estimated. [2014 Site ID:RD0524U01RM41.44]

Close view of the site. Dense vegetation covers the erosion.

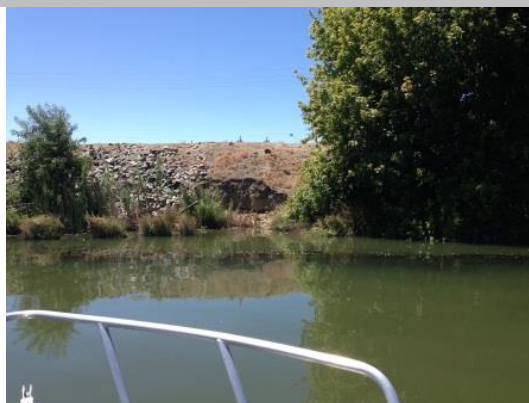
Photo 1 of 1 : SP_2015_RD0524_107_134_20150309_00133.jpg

LM Start	0.91	Rating **	U	Issue No.	134
LM End	0.91	Issue Type +	Ma	Location *	WS
Category	Supplemental			GPS Latitude/Longitude	
				Start	End
Item	DWR Erosion Survey			37.935576 °	37.935576 °
				-121.333202 °	-121.333202 °
DWR ID	DWR_RD0524_01_s_2015_134				
Action/Comments					
Inspector Comments: 6/19/2014: No significant change observed. 08/13/2013: No significant change at this site. 08/07/2012: The site has been visited by boat survey. No significant change observed 08/23/2011: The erosion site is immediately downstream of the riprap protection. [2014 Site ID:RD0524U01RM41.5]

Front view of the erosion. Note the riprap protection near the site.

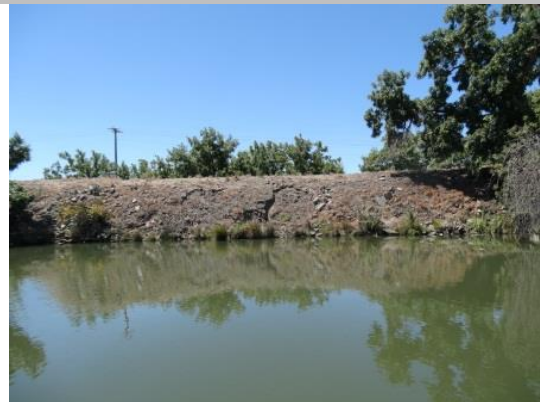
Photo 1 of 1 : SP_2015_RD0524_107_135_20150309_00134.jpg

LM Start	1.00	Rating **	U	Issue No.	135
LM End	1.00	Issue Type +	Ma	Location *	WS
Category	Supplemental			GPS Latitude/Longitude	
				Start	End
Item	DWR Erosion Survey			37.935410 °	37.935410 °
				-121.331560 °	-121.331560 °
DWR ID	DWR_RD0524_01_s_2015_135				
Action/Comments					
Inspector Comments: 6/19/2014: No significant change observed. 08/13/2013: No significant change at this site. 08/07/2012: The erosion was discovered during the boat survey. [2014 Site ID:RD0524U01RM41.58]

Close view of the erosion.

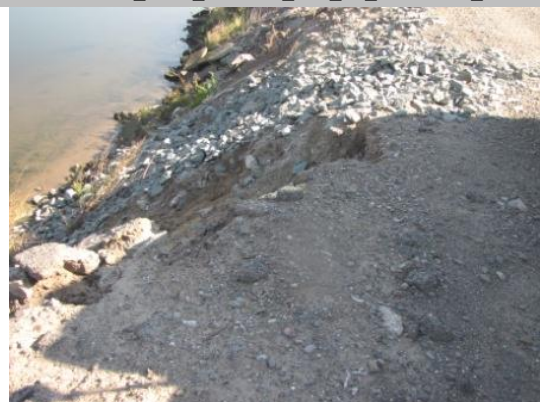
Photo 1 of 3 : SP_2015_RD0524_107_17_20150309_00023.jpg

LM Start	1.00	Rating **	M	Issue No.	17
LM End	1.02	Issue Type +	Ma	Location *	WS
Category	Earthen Levee			GPS Latitude/Longitude	
				Start	End
Item	Erosion / Bank Caving			37.935098 °	37.935018 °
				-121.331645 °	-121.331248 °
DWR ID	DWR_RD0524_01_s_2012_17				
Action/Comments					
Schedule repair of erosion site prior to the next inspection.					
Inspector Comments: Minor erosion was noted next to repaired site.

Looking upstream (south) at erosion site.

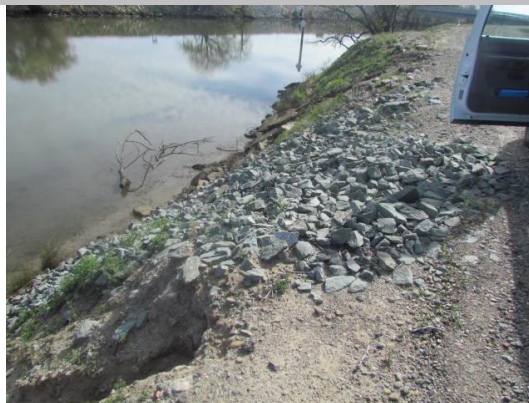
Photo 2 of 3 : SP_2015_RD0524_107_17_20150309_00024.jpg

LM Start	1.00	Rating **	M	Issue No.	17 (cont)
LM End	1.02	Issue Type +	Ma	Location *	WS
Category	Earthen Levee			GPS Latitude/Longitude	
				Start	End
Item	Erosion / Bank Caving			37.935098 °	37.935018 °
				-121.331645 °	-121.331248 °
DWR ID	DWR_RD0524_01_s_2012_17				
Action/Comments					
Schedule repair of erosion site prior to the next inspection.					
Inspector Comments: Minor erosion was noted next to repaired site.

Looking southeast at erosion next to repaired site on waterward slope (Spring 2013)

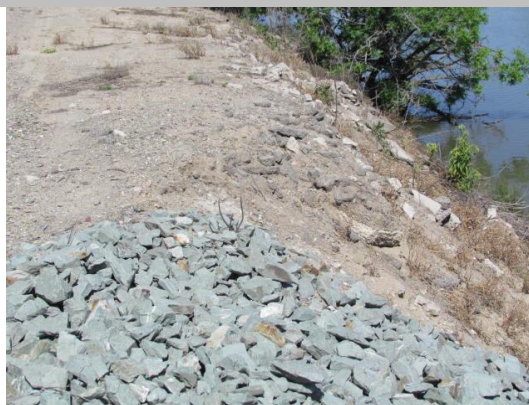
Photo 3 of 3 : SP_2015_RD0524_107_17_20150309_00025.jpg

Looking north at erosion site next to repaired site. (Spring 2012)

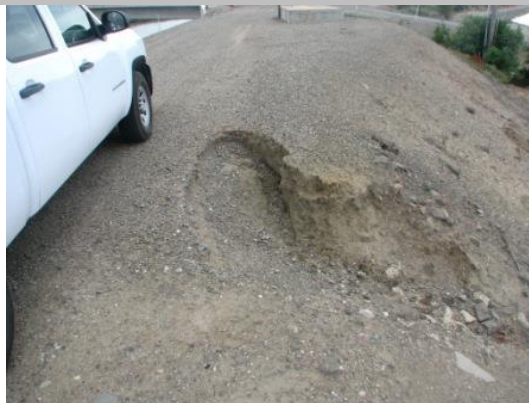
Photo 2 of 6 : SP_2015_RD0524_107_18_20150309_00026.jpg

Landward slope damage.

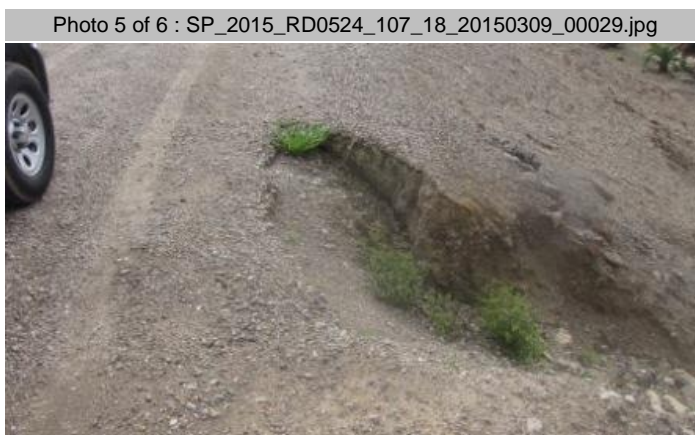
LM Start	1.08	Rating **	M	Issue No.	18 (cont)	
LM End	1.08	Issue Type +	Ma	Location *	LS	
Category	Earthen Levee			GPS Latitude/Longitude		
				Start		End
Item	Slope Stability			37.934645 °		37.934645 °
				-121.330310 °		-121.330310 °
DWR ID	DWR_RD0524_01_s_2012_18					
Action/Comments						
Repair slope instability. Inspector Comments: Slope damage extend from shoulder to middle of slope.

Looking at updated slope stability as of 4/2010.

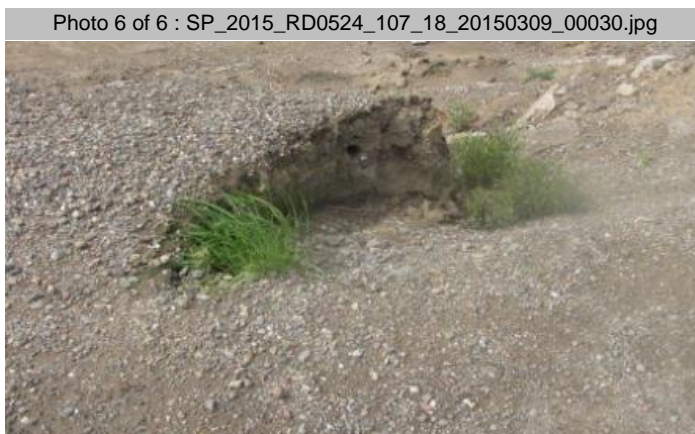
Updated view from above the slope stability.

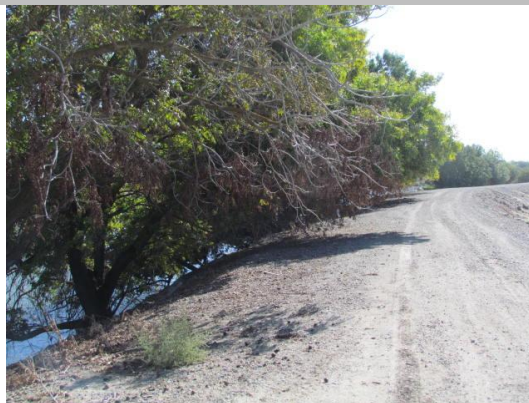
Photo 1 of 1 : SP_2015_RD0524_107_19_20150309_00031.jpg

Looking northwest at low hanging tree branches at waterside toe.

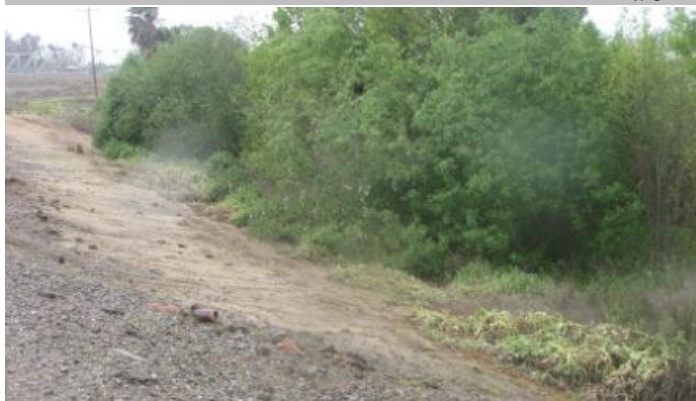
Photo 1 of 1 : SP_2015_RD0524_107_915_20150309_00164.jpg

Looking southwest at dense veg. on landside toe.

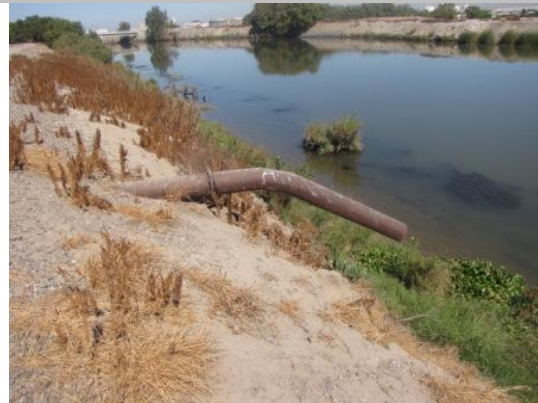
Photo 2 of 2 : SP_2015_RD0524_107_33_20150309_00047.jpg

Looking north at broken pipe.

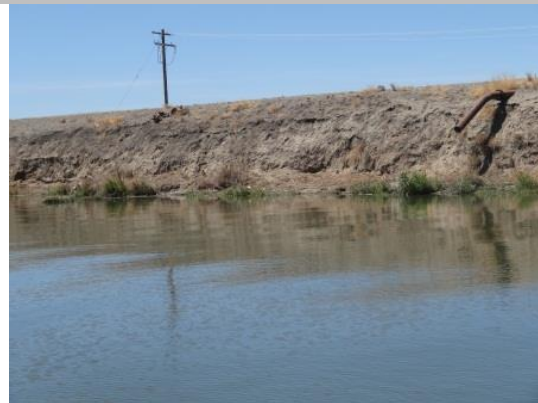
Photo 1 of 1 : SP_2015_RD0524_107_142_20150309_00138.jpg

Front view of the erosion. Note the drainage pipe on the site.

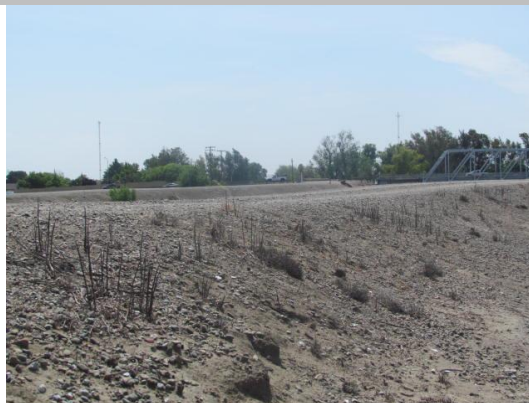
Photo 1 of 2 : SP_2015_RD0524_107_172_20150424_00211.jpg

Looking east at depression on levee crown.

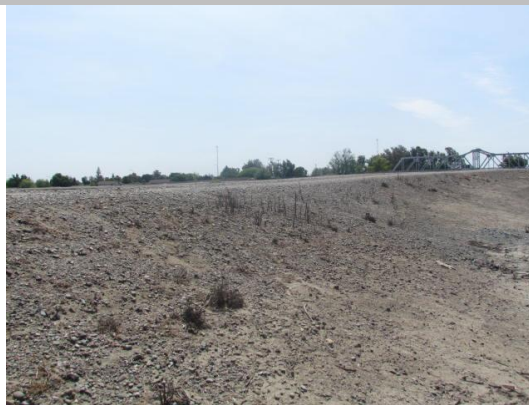
Photo 2 of 2 : SP_2015_RD0524_107_172_20150424_00212.jpg

Looking southeast at depression on levee crown.

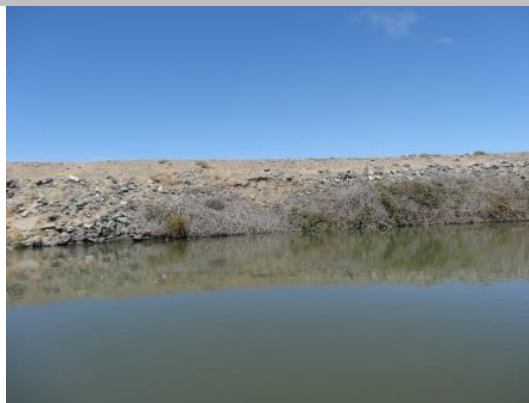
Photo 1 of 1 : SP_2015_RD0524_107_144_20150309_00140.jpg

Front view of the erosion site.

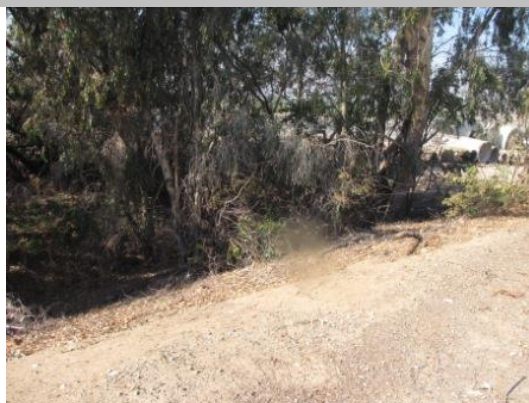
Photo 1 of 3 : SP_2015_RD0524_107_916_20150309_00165.jpg

Dense vegetation on landside toe.

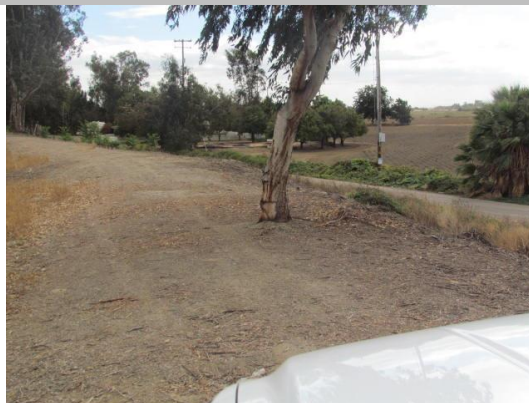
Photo 5 of 5 : SP_2015_RD0524_107_23_20150309_00038.jpg

Looking south from levee crown at upstream end of corrected site.

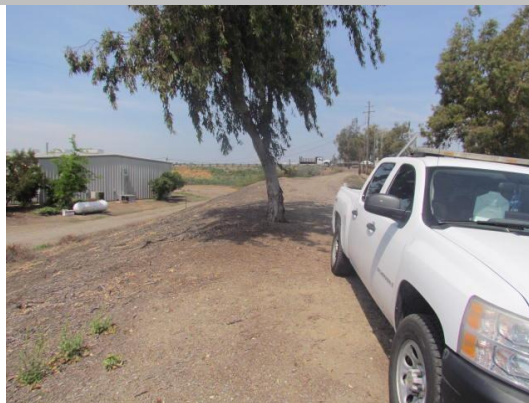
Photo 1 of 1 : SP_2015_RD0524_107_173_20150424_00213.jpg

Looking northwest at tree on within levee crown.

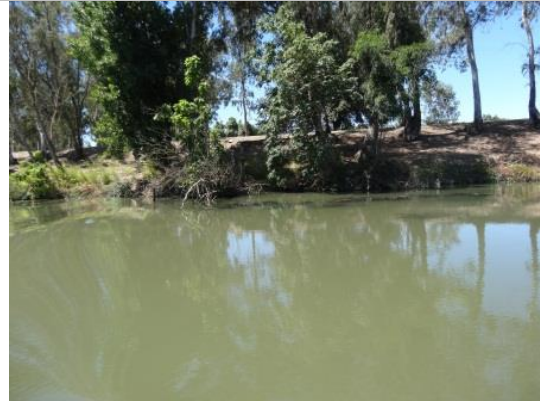
Photo 1 of 1 : SP_2015_RD0524_107_145_20150309_00141.jpg

Front view of the site where undermining has occurred.

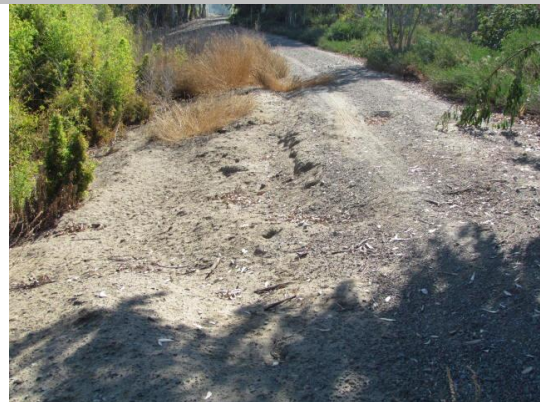
Photo 1 of 1 : SP_2015_RD0524_107_136_20150309_00135.jpg

Looking south at depression on levee crown near waterward shoulder.

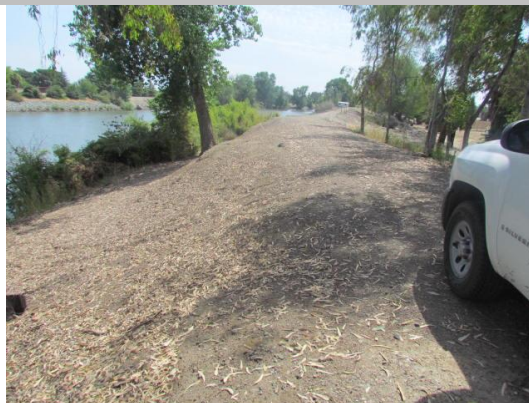
Photo 1 of 1 : SP_2015_RD0524_107_27_20150424_00217.jpg

Looking south at landward slope depression.

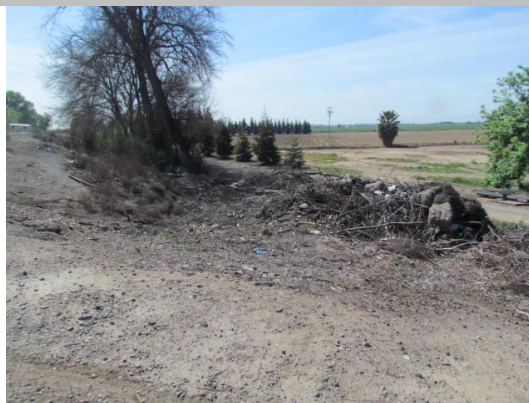
Photo 2 of 2 : SP_2015_RD0524_107_28_20150309_00043.jpg

Looking at southwest at a pruning pile at landward berm.

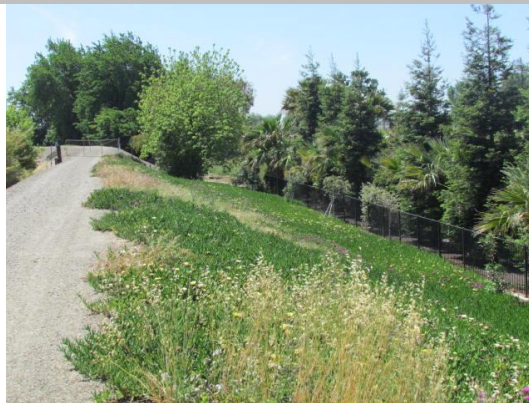
Photo 1 of 1 : SP_2015_RD0524_107_78_20150309_00090.jpg

Looking southwest at landscaping on landside slope. (Spring 2012)

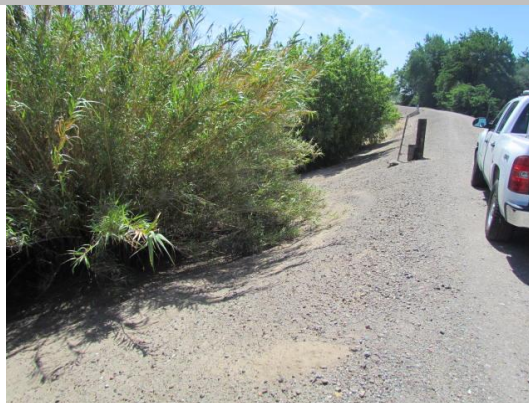
Photo 2 of 2 : SP_2015_RD0524_107_104_20150309_00107.jpg

Looking southeast at bamboo on waterside slope.

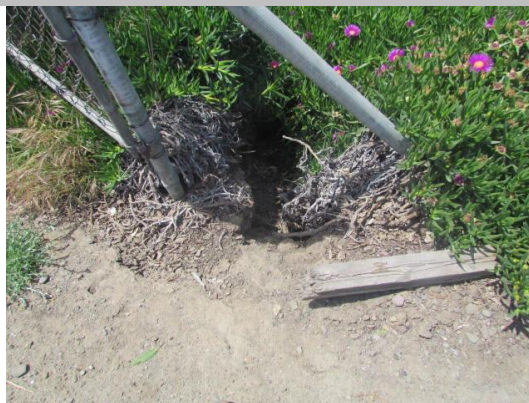
Photo 1 of 2 : SP_2015_RD0524_107_176_20150424_00218.jpg

Looking west at erosion within landscaping on landward shoulder and slope.

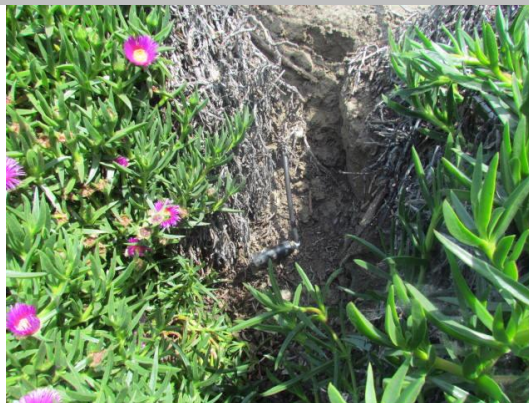
Photo 2 of 2 : SP_2015_RD0524_107_176_20150424_00219.jpg

Looking east at erosion within landscaping on landward slope and shoulder.

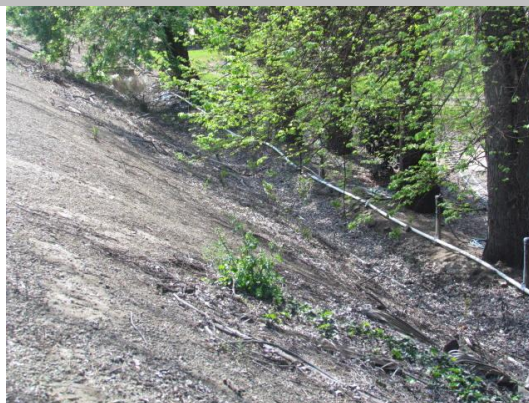
Photo 2 of 2 : SP_2015_RD0524_107_182_20150309_00151.jpg

Looking southwest at an old irrigation ditch at landward toe.

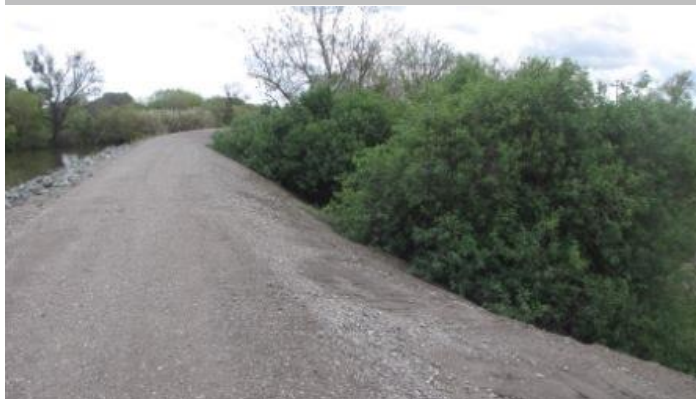
Photo 1 of 1 : SP_2015_RD0524_107_32_20150309_00045.jpg

Looking south at dense veg on landside slope and toe.

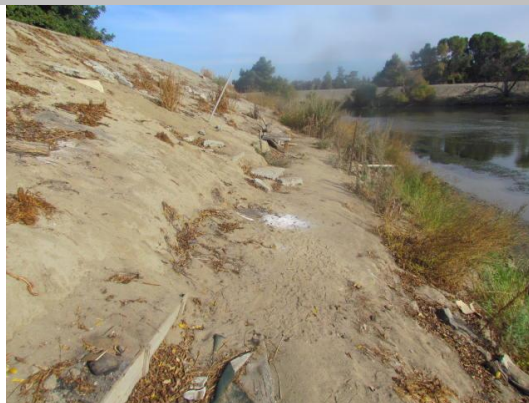
Photo 1 of 1 : SP_2015_RD0524_107_34_20150309_00048.jpg

Looking northeast at damage to the slope possibly caused by human activity.

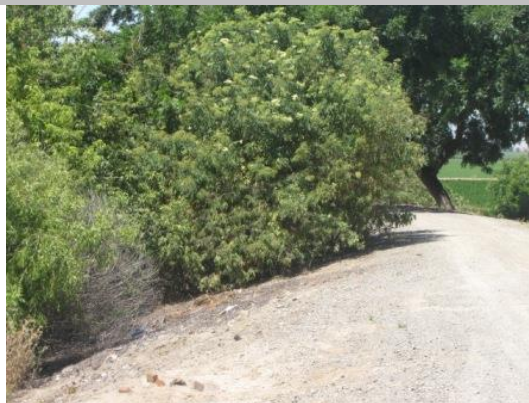
Photo 2 of 2 : SP_2015_RD0524_107_38_20150309_00056.jpg

Looking south at elderberry on waterside slope.

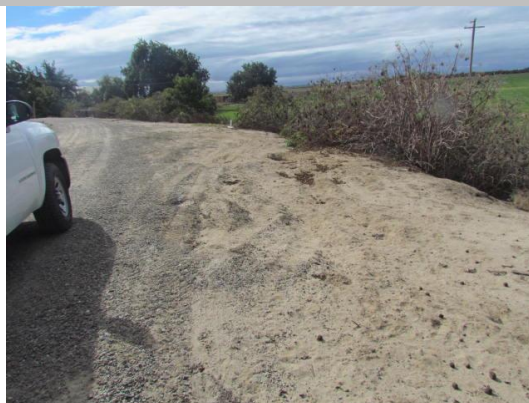
Photo 1 of 1 : SP_2015_RD0524_107_82_20150309_00094.jpg

Looking southwest at damaged landward slope.

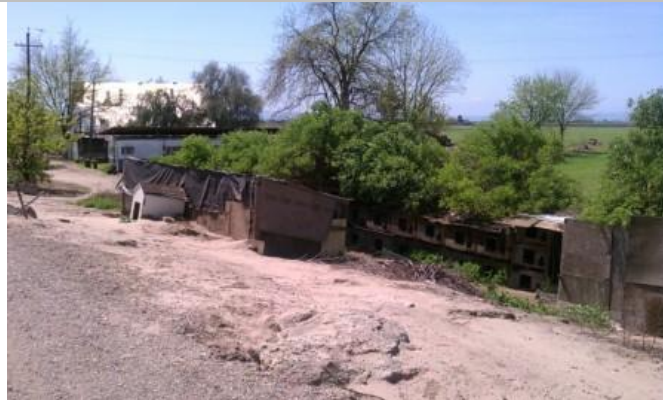
Photo 2 of 2 : SP_2015_RD0524_107_42_20150309_00060.jpg

Looking at animal pens on landside slope and toe.

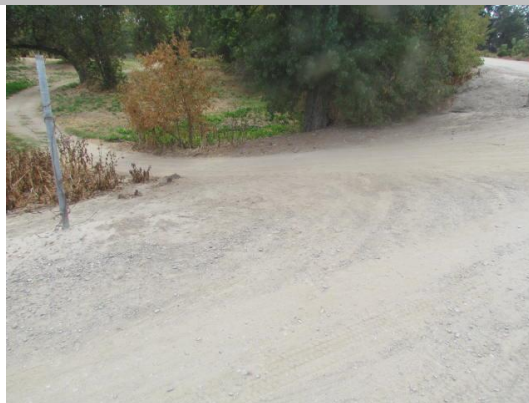
Photo 1 of 1 : SP_2015_RD0524_107_7_20150309_00011.jpg

Looking southeast at unauthorized ramp on waterside slope.

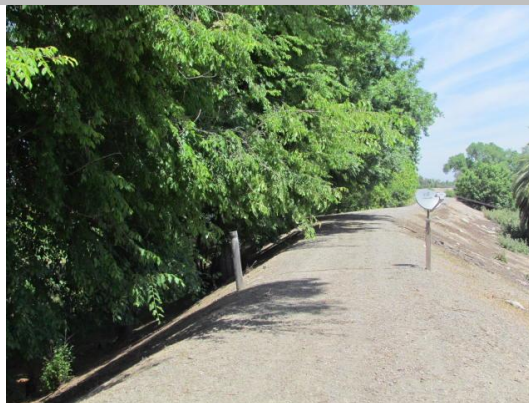
Photo 1 of 1 : SP_2015_RD0524_107_44_20150309_00061.jpg

Looking north at dense trees overhanging levee crown.

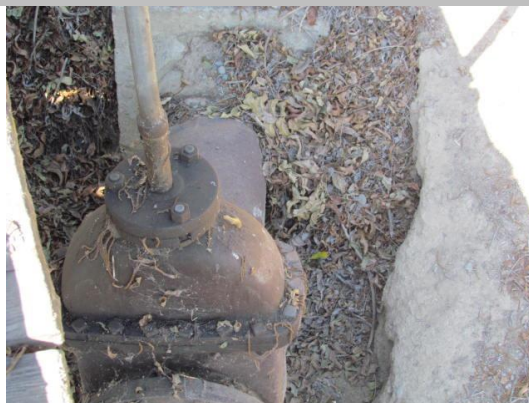
Photo 1 of 2 : SP_2015_RD0524_107_21_20150309_00032.jpg

Looking at erosion around irrigation pipe on waterward slope.

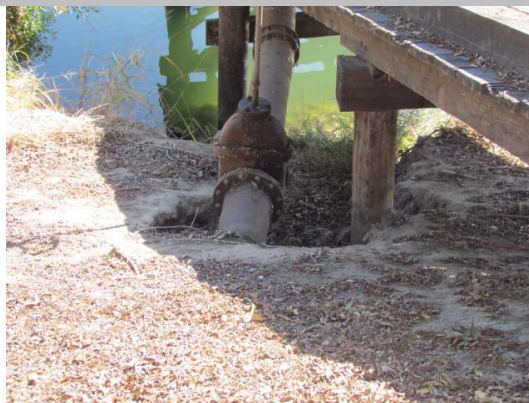
Photo 2 of 2 : SP_2015_RD0524_107_21_20150309_00033.jpg

Looking east at erosion around irrigation pipe on waterward slope.

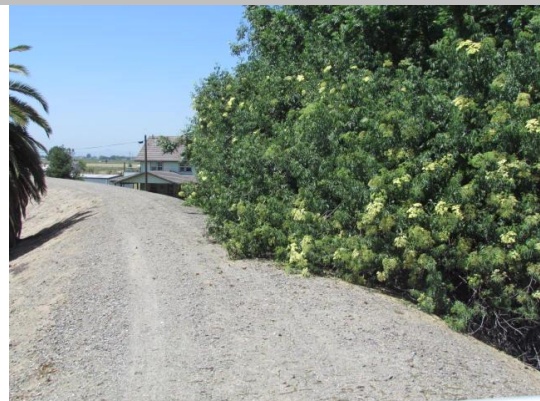
Photo 1 of 2 : SP_2015_RD0524_107_48_20150309_00069.jpg

Looking south at dense elderberry on landside slope.(Spring 2012)

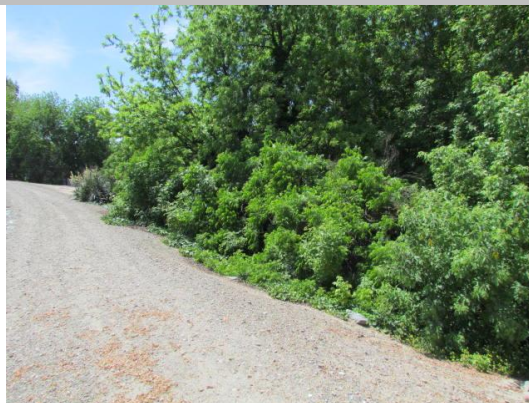
Photo 1 of 1 : SP_2015_RD0524_107_92_20150309_00097.jpg

Looking southwest at dense landscaping on landside slope.

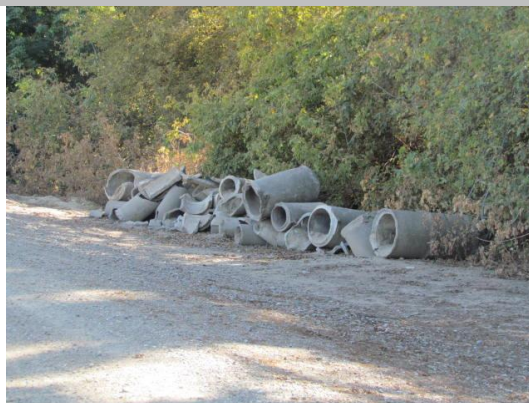
Photo 1 of 1 : SP_2015_RD0524_107_56_20150309_00075.jpg

Looking southwest at concrete pipes on landside toe.

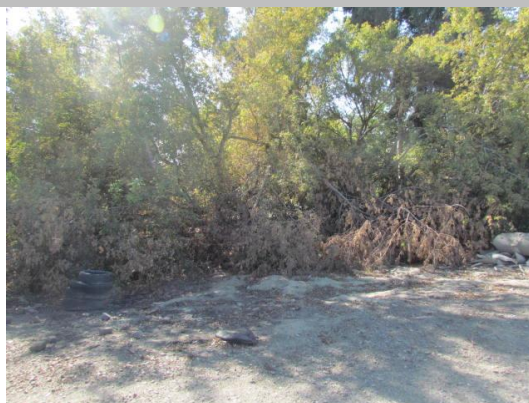
Photo 1 of 1 : SP_2015_RD0524_107_93_20150309_00098.jpg

Looking northwest at low hanging tree branches on landside slope and toe.

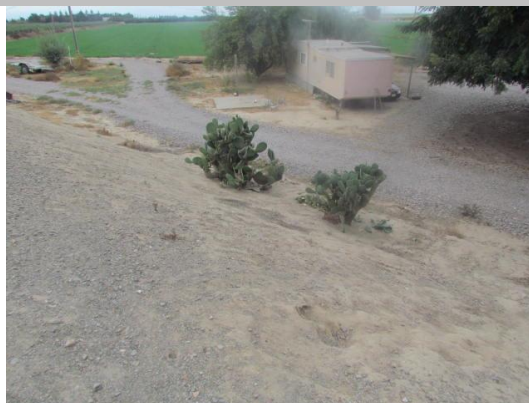
Photo 1 of 1 : SP_2015_RD0524_107_124_20150309_00125.jpg

Looking west at cactus on landside toe.

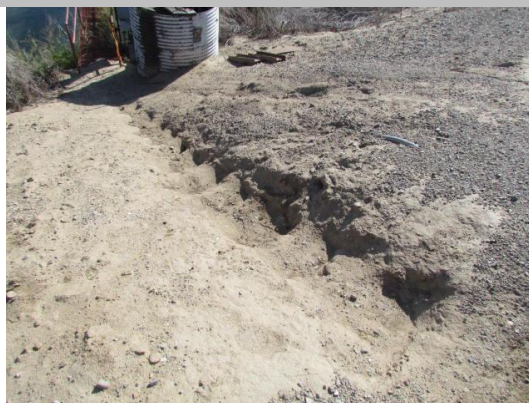
Photo 1 of 1 : SP_2015_RD0524_107_58_20150309_00077.jpg

Looking southeast steps cut into waterside slope.

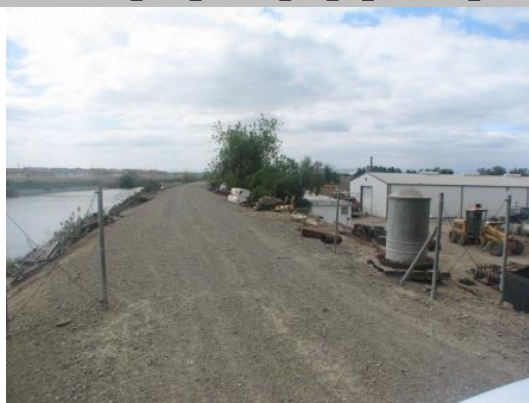
Photo 2 of 2 : SP_2015_RD0524_107_62_20150309_00079.jpg

Looking upstream at equipment on landside shoulder

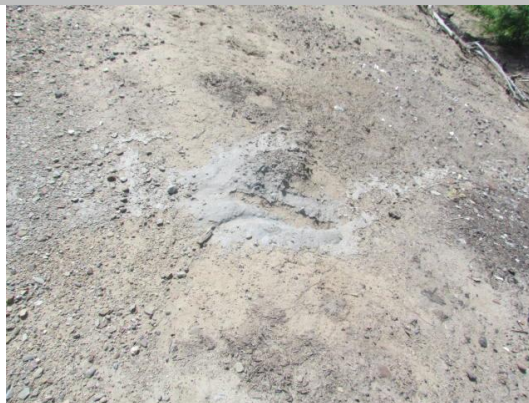
Photo 1 of 1 : SP_2015_RD0524_107_64_20150424_00229.jpg

Looking at typical view of grouted rodent holes on landward slope.

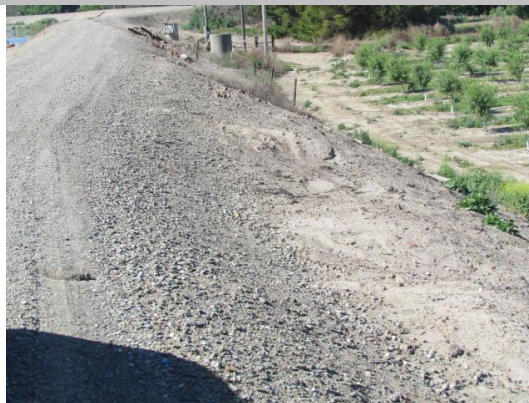
Photo 1 of 1 : SP_2015_RD0524_107_108_20150309_00109.jpg

Looking southwest at caving slope on landside of levee.

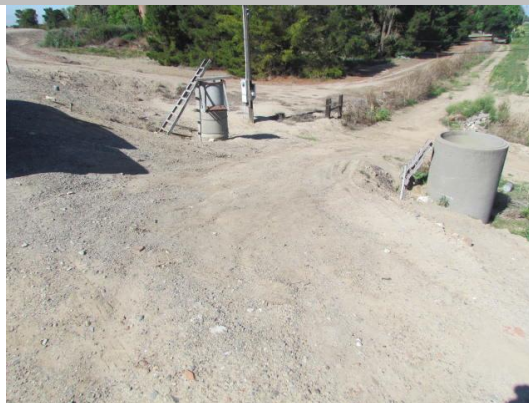
Photo 1 of 1 : SP_2015_RD0524_107_110_20150309_00115.jpg

Looking southwest at an unauthorized ramp on landside slope.

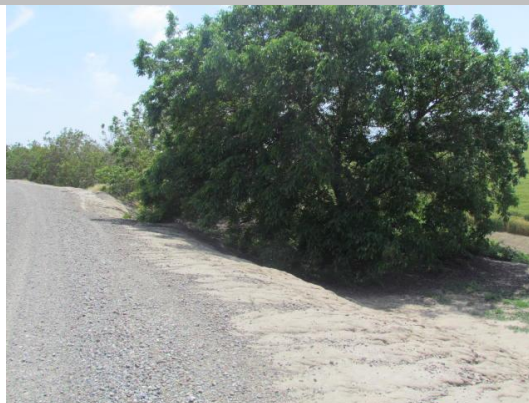
Photo 1 of 1 : SP_2015_RD0524_107_112_20150424_00230.jpg

Looking southeast at untrimmed tree at landward toe.

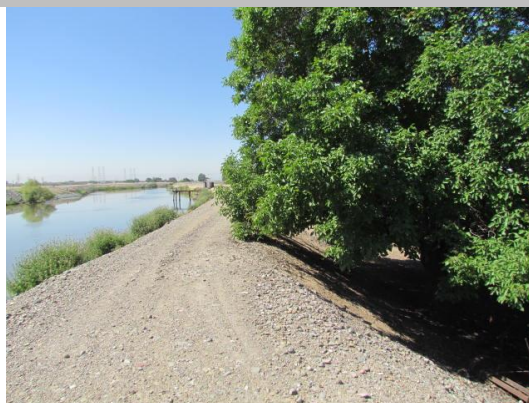
Photo 1 of 1 : SP_2015_RD0524_107_63_20150309_00080.jpg

Looking south at dense trees on landside slope.

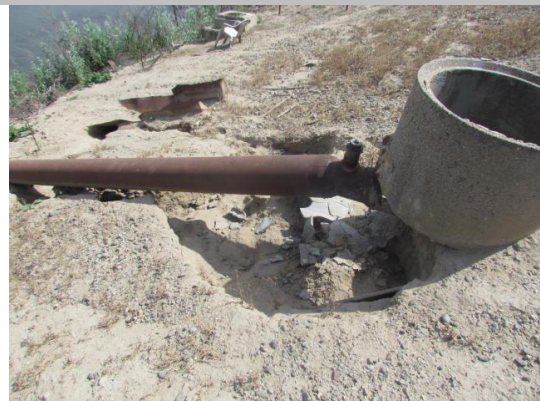
Photo 1 of 3 : SP_2015_RD0524_107_198_20150424_00239.jpg

Looking south at erosion around irrigation pipe on waterward slope.
